# UPDATE NOTE

*from firmware V4 to firmware V5*

Mini Motor S.P.A.

FW-UPD-V5-EN

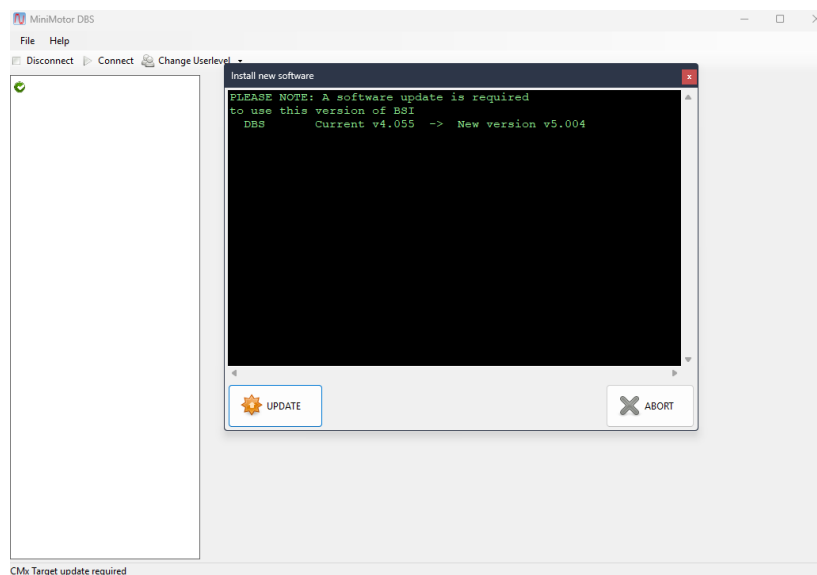
Figure 1. The BSI proposes the firmware update from V4 to V5

Press **UPDATE** and wait for the process to finish, then press **CLOSE**. It is the same procedure as any firmware update, also described in the Parametrization Interface chapter of the manual.

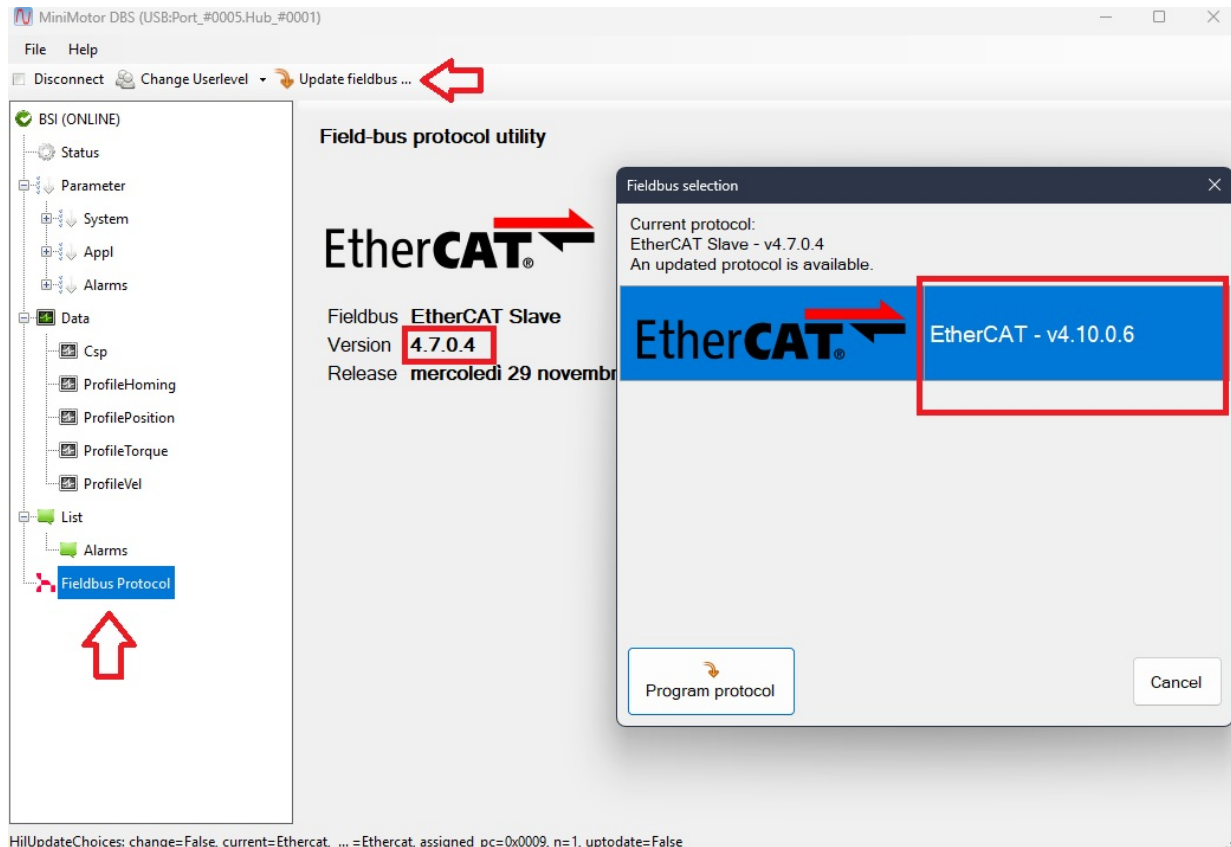
The **Field-bus protocol utility** page shows the protocol installed on the fieldbus board and its version. In the **Fieldbus selection** window the BSI reports the current protocol and, below it, the message **An updated protocol is available**: it means the stack on board is the old one.

Figure 2. Protocol stack update: Fieldbus Protocol page and Fieldbus selection window

1. Select in the list the proposed protocol, with the new version. In the example in the figure the motor has EtherCAT, with stack 4.7.0.4, and the BSI proposes **EtherCAT - v4.10.0.6**.
2. Press **Program protocol**.
3. Wait for the programming to finish: at the end the motor restarts on its own. Do not disconnect it or remove the power supply before the restart.
